STABILITY ANALYSIS AND REINFORCEMENT OF A LANDSLIDE IN THE GUELMA'S WILAYA ROAD (EASTERN ALGERIA)

A. Aissi, K. Omraci, A.Mimoun, National Higher school of Mining and Metallurgy, Algeria
A.I. Kanli, O.Sekiou, Istanbul University, Faculty of Engineering, Department of Geophysical Engineering Istanbul, Turkey

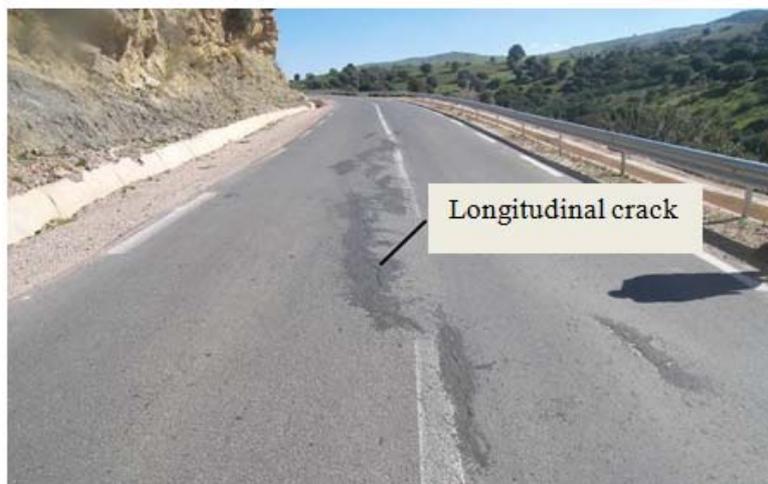
Our objective in this research is to analyze and address the instability situated at kilometer N 50 + 500, on the wilaya road №19 connecting the Daira Hammam N'bail and Guelma town. In this section, we focus on the analysis of the slope stability based on geology, hydrogeology, and hydro-climatology. The results of geotechnical investigations in the area, as well the investigated site including *in-situ* tests and those of the laboratory in 2011, there were no signs of instability on the upstream and downstream slope (fig. 1). Only a longitudinal crack in the axis of the road (cut and fill mixed profile) exists with a collapse of the embankment part. It could be that this crack is the result of a settlement of the embankment part recently executed [4].

Fig.1. Embankment crack (February 2011) (DTP Guelma)

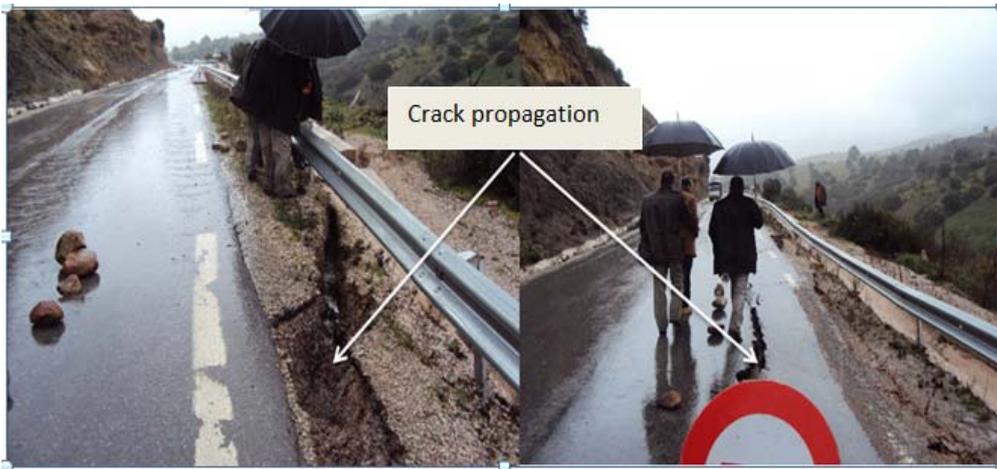
April 2012; a collapse of about 300 m from the roadway embankment half rating (fig. 2). They are defined by UHF cracks with subsidence of up to 50cm and sometimes more. The rehabilitation of the road needs permanent mobilization maintenance teams STP KHEZARA [4].

Fig.2.Degradation of the site at the rainy season of April 2012 (Zemouri& Arab, 2012).

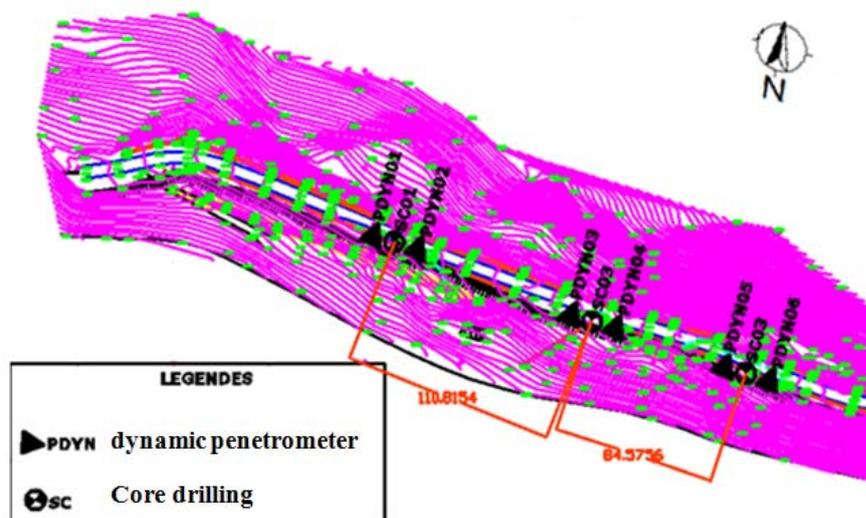
As part of the study preliminary design, and according to the studies program and recognition of the LABORATORY Control and Expertise (L.C.E.E) Constantine, surveys were conducted along the area affected by the landslide (Fig. 3).

Fig.4.Plan view of the site with implantation of the drilling investigation (Zemouri& Arab, 2012) amended.

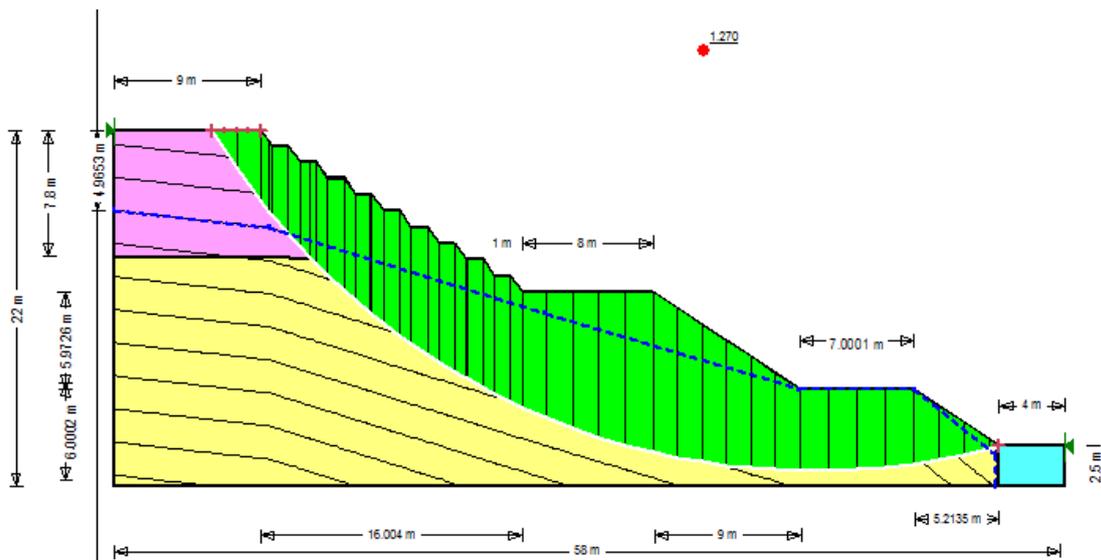
Fig. 5.The critical slip circle around the slopes after reprofiling in the dry period (result calculated by the method of Fellenius)

In the case of the CW19 area PK 50 + 500, the reprofiling is selected for several benefits(fig . 5).Firstly, and mainly, to get away from the area affected by the landslide, secondly to minimize the weight concentrated on the slope top, as a consequence ensuring stability of the slope.
